**Flood Control Project Maintenance  
Levee Inspections**

## Maintenance Issue Types Only, Levee Inspection Report By Mile - Spring 2017

### Reclamation District No. 2060 Hastings

Waterway	Bank	Unit Miles	Inspection Start/End	Inspector
Unit No. 01 Lindsey Slough	Left	6.97	04/21/2017 04/21/2017	Herman Phillips

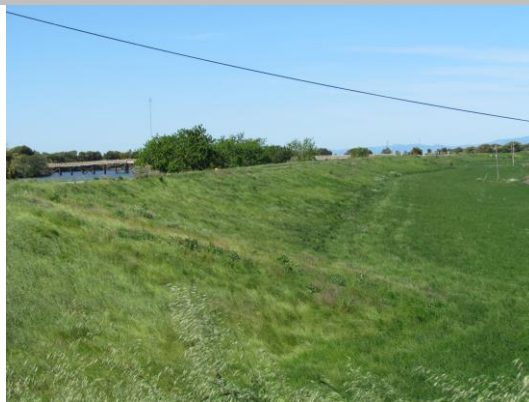
Photo 1 of 1 : SP\_2017\_RD2060\_241\_5\_20170424\_00008.jpg

LM Start	0.00	Rating **	M	Issue No.	5
LM End	5.08	Issue Type +	Ma	Location *	LS
Category	Earthen Levee		GPS Latitude/Longitude		
			Start	End	
Item	Vegetation		38.247342 °	38.263293 °	
			-121.696283 °	-121.771557 °	
DWR ID	DWR_RD2060_01_f_2016_5				
Comment Code					
V1 : Control annual grass and weeds on the levee slopes and easements.					
Inspector Comment					
The landside levee slope will be sprayed later this spring.

RD 2060 Landside slope looking downstream from levee mile 0.00.

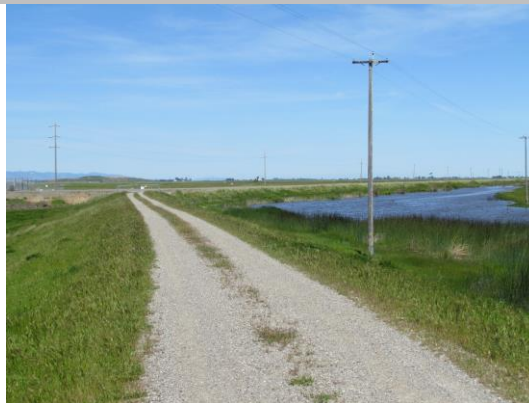
Photo 1 of 1 : SP\_2017\_RD2060\_242\_8\_20170424\_00010.jpg

LM Start	0.01	Rating **	A	Issue No.	8
LM End	0.37	Issue Type +	Ma	Location *	WS
Category	Earthen Levee			GPS Latitude/Longitude	
				Start	End
Item	Vegetation			38.275085 °	38.280063 °
				-121.794940 °	-121.795928 °
DWR ID	DWR_RD2060_02_s_2017_8				
Comment Code					
V1 : Control annual grass and weeds on the levee slopes and easements.					
Inspector Comment					
This section of levee the vegetation is acceptable.

Looking downstream from levee mile 0.01.

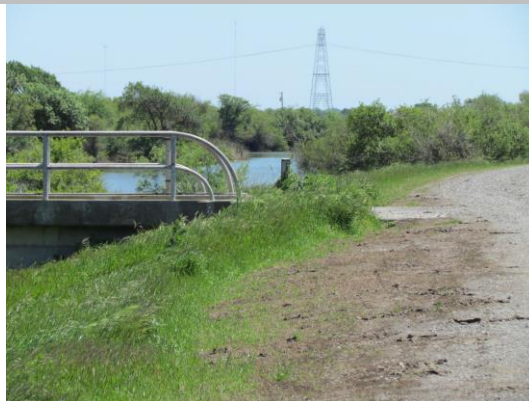
Photo 1 of 1 : SP\_2017\_RD2060\_243\_14\_20170424\_00022.jpg

LM Start	0.01	Rating **	U	Issue No.	14
LM End	4.99	Issue Type +	Ma	Location *	WS
Category	Earthen Levee			GPS Latitude/Longitude	
				Start	End
Item	Vegetation			38.296617 °	38.247960 °
				-121.748565 °	-121.696175 °
DWR ID	DWR_RD2060_03_s_2017_14				
Comment Code					
V1 : Control annual grass and weeds on the levee slopes and easements.					
Inspector Comment					
Remove the tall weeds from the waterside slope.

Looking downstream from levee mile 0.01 at the waterside slope and shoulder.

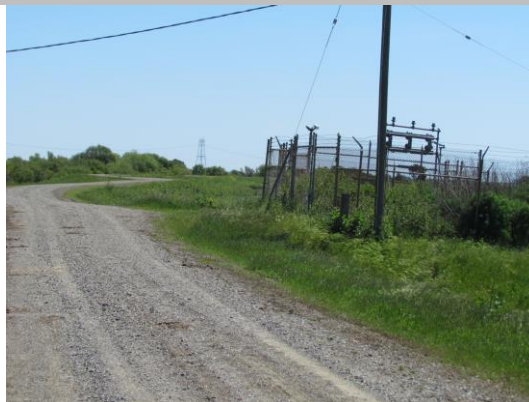
Photo 1 of 1 : SP\_2017\_RD2060\_243\_13\_20170424\_00016.jpg

LM Start	0.01	Rating **	M	Issue No.	13
LM End	5.01	Issue Type +	Ma	Location *	LS
Category	Earthen Levee			GPS Latitude/Longitude	
				Start	End
Item	Vegetation			38.296617 °	38.247650 °
				-121.748565 °	-121.696217 °
DWR ID	DWR_RD2060_03_s_2017_13				
Comment Code					
V1 : Control annual grass and weeds on the levee slopes and easements.					
Inspector Comment					
Spray to control the annual grass and weeds from the landside slope.

Looking downstream from levee mile 0.01.

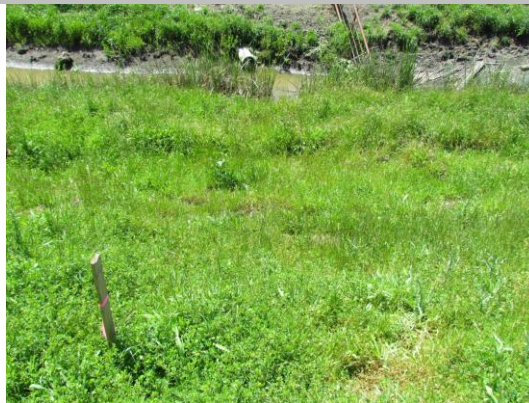
Photo 1 of 2 : SP\_2017\_RD2060\_243\_16\_20170424\_00023.jpg

LM Start	0.07	Rating **	U	Issue No.	16
LM End	0.07	Issue Type +	Ma	Location *	LS
Category	Earthen Levee			GPS Latitude/Longitude	
				Start	End
Item	Erosion / Bank Caving			38.296350 °	38.296302 °
				-121.747642 °	-121.747565 °
DWR ID	DWR_RD2060_03_s_2017_16				
Comment Code					
E1 : Note and monitor erosion site.					
Inspector Comment

Looking down from the shoulder at the sloughing in the slope towards the irrigation ditch at toe.

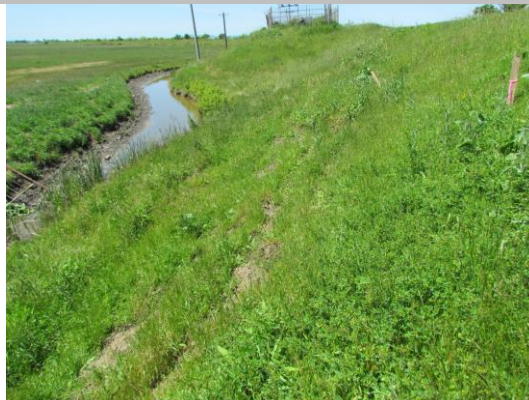
Photo 2 of 2 : SP\_2017\_RD2060\_243\_16\_20170424\_00025.jpg

LM Start	<b>0.07</b>	Rating **	U	Issue No.	<b>16 (cont)</b>
LM End	<b>0.07</b>	Issue Type +	Ma	Location *	LS

Standing on the slope looking upstream at the slough.

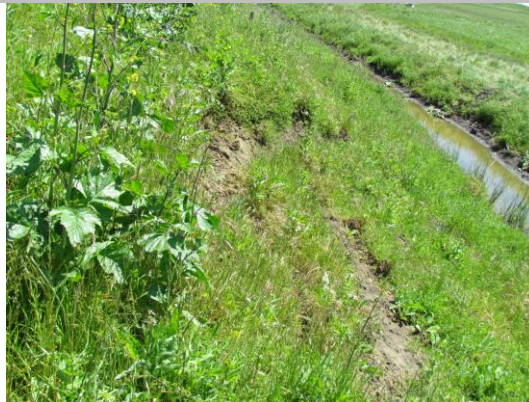
Photo 1 of 2 : SP\_2017\_RD2060\_243\_19\_20170424\_00017.jpg

LM Start	0.15	Rating **	M	Issue No.	19
LM End	0.19	Issue Type +	Ma	Location *	LS
Category	Earthen Levee			GPS Latitude/Longitude	
				Start	End
Item	Slope Stability			38.295738 °	38.295559 °
				-121.746293 °	-121.745583 °
DWR ID	DWR_RD2060_03_s_2017_19				
Comment Code					
S1 : Repair slope instability.					
Inspector Comment					
There are several signs of sloughing occuring on the slope notices after the flood event Feb. 2017 storm.

Standing at levee mile 0.15 looking downstream from the landside slope.

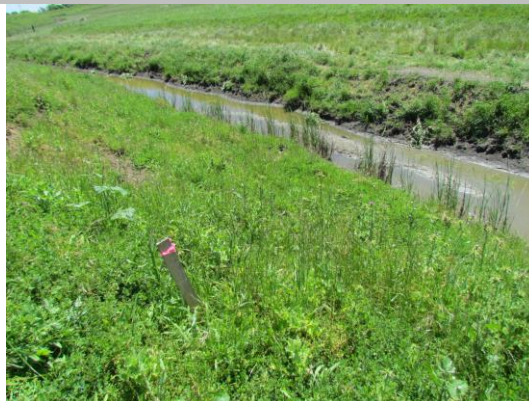
Photo 2 of 2 : SP\_2017\_RD2060\_243\_19\_20170424\_00018.jpg

LM Start	0.15	Rating **	M	Issue No.	19 (cont)	
LM End	0.19	Issue Type +	Ma	Location *	LS	
Category	Earthen Levee			GPS Latitude/Longitude		
				Start		End
Item	Slope Stability			38.295738 °		38.295559 °
				-121.746293 °		-121.745583 °
DWR ID	DWR_RD2060_03_s_2017_19					
Comment Code						
S1 : Repair slope instability.						
Inspector Comment						
There are several signs of sloughing occuring on the slope notices after the flood event Feb. 2017 storm.

Just upstream of the erosion site looking downstream from the landside slope.

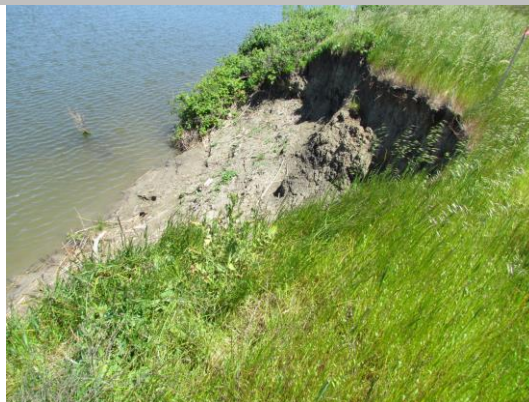
Photo 1 of 2 : SP\_2017\_RD2060\_243\_18\_20170424\_00019.jpg

LM Start	1.12	Rating **	U	Issue No.	18
LM End	1.12	Issue Type +	Ma	Location *	WS
Category	Earthen Levee			GPS Latitude/Longitude	
				Start	End
Item	Slope Stability			38.290558 °	38.290558 °
				-121.731580 °	-121.731580 °
DWR ID	DWR_RD2060_03_s_2017_18				
Comment Code					
S1 : Repair slope instability.					
Inspector Comment					
The District has scheduled repairs of this site.

Looking downstream at the erosion in the waterside slope and toe.

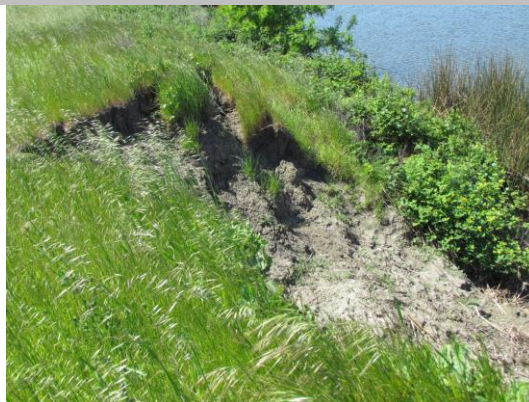
Photo 2 of 2 : SP\_2017\_RD2060\_243\_18\_20170424\_00021.jpg

LM Start	<b>1.12</b>	Rating **	U	Issue No.	<b>18 (cont)</b>
LM End	<b>1.12</b>	Issue Type +	Ma	Location *	WS

Looking upstream at the erosion on the waterside slope.

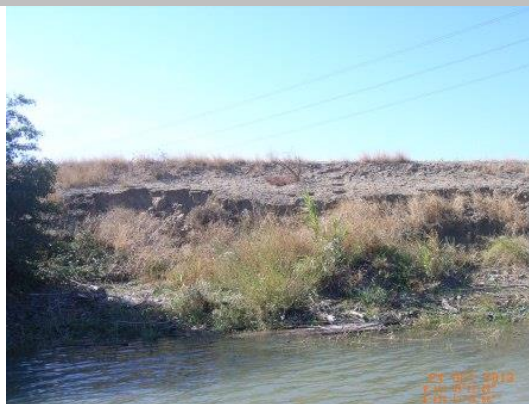
Photo 1 of 1 : SP\_2017\_RD2060\_243\_8\_20170404\_00007.jpg

LM Start	1.52	Rating **	M	Issue No.	8
LM End	1.74	Issue Type +	Ma	Location *	WS
Category	Supplemental			GPS Latitude/Longitude	
				Start	End
Item	2015 USACE Erosion Survey, DRAFT			38.288598 °	38.286051 °
				-121.725184 °	-121.722818 °
DWR ID	DWR_RD2060_03_s_2016_8				
Comment Code					
Inspector Comment					
Site added in 1997 and removed in 2003. 2005 - Put back in the inventory. 2006 - Stone repair at the middle of the site. 2011 - Some rock place at toe in the past year. 2013 - Site extended both upstream and downstream to include new erosion pockets. 2015: No observed changes. [2015 Site ID: CHS_23-6_R]

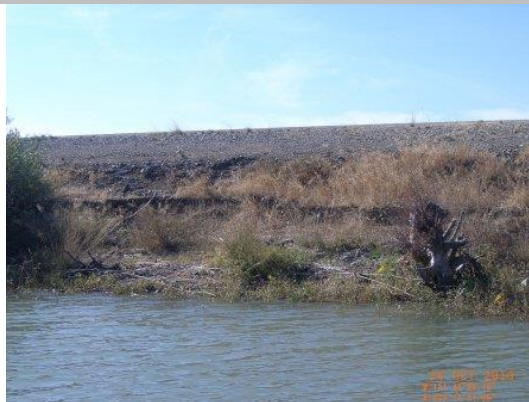
Photo 1 of 1 : SP\_2017\_RD2060\_243\_1\_20170404\_00001.jpg

LM Start	2.02	Rating **	M	Issue No.	1
LM End	2.08	Issue Type +	Ma	Location *	WS
Category	Supplemental			GPS Latitude/Longitude	
				Start	End
Item	2015 USACE Erosion Survey, DRAFT			38.284105 °	38.283302 °
				-121.718471 °	-121.717814 °
DWR ID	DWR_RD2060_03_s_2016_1				
Comment Code					
Inspector Comment					
2010 - Small maintenance site. 2015: No observed changes. [2015 Site ID: CHS_23-0_R]

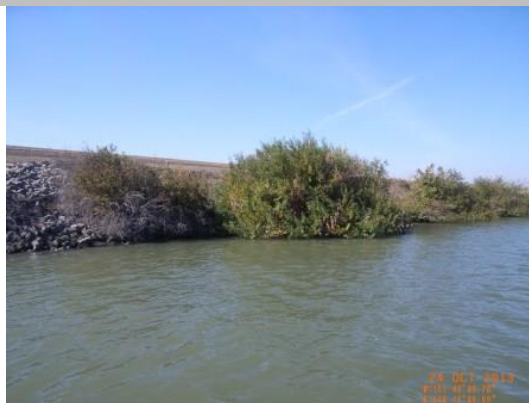
Photo 1 of 1 : SP\_2017\_RD2060\_243\_5\_20170404\_00004.jpg

LM Start	2.55	Rating **	M	Issue No.	5
LM End	2.58	Issue Type +	Ma	Location *	WS
Category	Supplemental			GPS Latitude/Longitude	
				Start	End
Item	2015 USACE Erosion Survey, DRAFT			38.278145 °	38.277774 °
				-121.712609 °	-121.712137 °
DWR ID	DWR_RD2060_03_s_2016_5				
Comment Code					
Inspector Comment					
2013 - Erosion pockets into the levee toe. 2015: Erosion pockets have increased in size. [2015 Site ID: CHS_22-5_R]

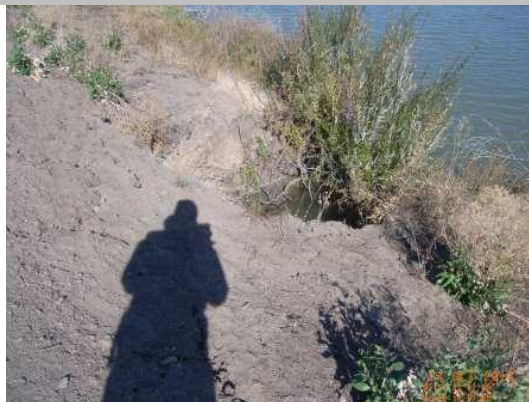
Photo 1 of 1 : SP\_2017\_RD2060\_243\_6\_20170404\_00005.jpg

LM Start	2.79	Rating **	M	Issue No.	6
LM End	2.79	Issue Type +	Ma	Location *	LS
Category	Earthen Levee			GPS Latitude/Longitude	
				Start	End
Item	Slope Stability			38.275302 °	38.275302 °
				-121.710130 °	-121.710127 °
DWR ID	DWR_RD2060_03_s_2016_6				
Comment Code					
S1 : Repair slope instability.					
Inspector Comment

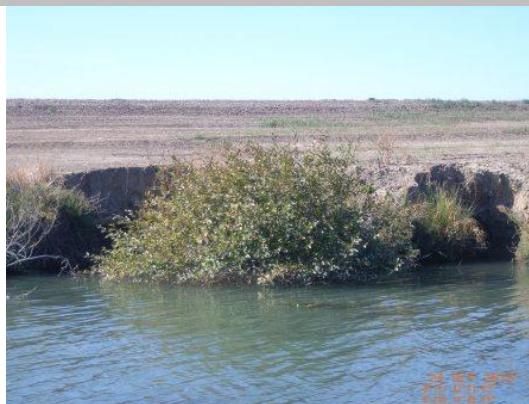
Photo 1 of 1 : SP\_2017\_RD2060\_243\_2\_20170404\_00002.jpg

LM Start	3.78	Rating **	M	Issue No.	2
LM End	4.09	Issue Type +	Ma	Location *	WS
Category	Supplemental			GPS Latitude/Longitude	
				Start	End
Item	2015 USACE Erosion Survey, DRAFT			38.264585 °	38.260593 °
				-121.698868 °	-121.696403 °
DWR ID	DWR_RD2060_03_s_2016_2				
Comment Code					
Inspector Comment					
2011 - Several pockets of erosion from rotational failure and slumping toe. 2013 - Site extended downstream to include new erosion pockets. 2015: No observed changes. [2015 Site ID: CHS_21-1_R]
